PROPERTY INSPECTION REPORT

1205 N Drexel
Indianapolis IN 46201

February 4, 2005

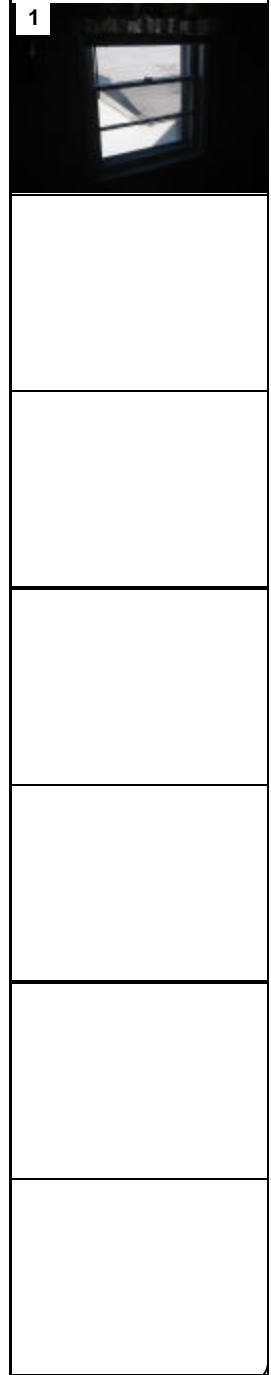
2nd floor bedroom window is stuck shut. - (See Photo 1)
